Tight control of cycle chemistry key to successful commissioning

By **Dr Otakar Jonas, PE**, and **Lee Machemer, PE**,
Jonas Inc

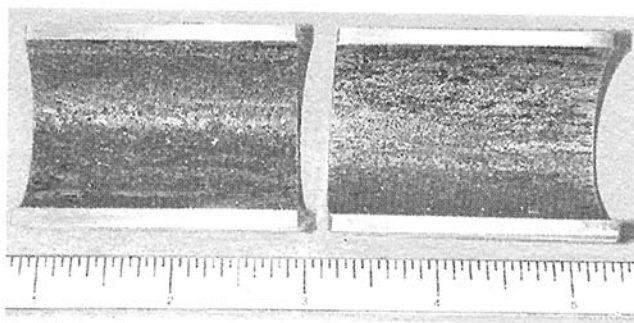
1. Water from hydrostatic test that remains in HRSG panels causes corrosion

Event. A boroscope examination during erection revealed significant amounts of rust in the tubes and headers in many HRSG sections.

Root cause. HRSG sections had not been completely drained after the factory hydrotest and had been inadequately protected during shipment. During erection, black water poured out of the assemblies. The water level during shipment with tubes in the horizontal position was evident in the boroscope videos because the rust was mainly in the bottom half of the tubes (Fig 1).

Action. Unscheduled pre-operational chemical cleaning.

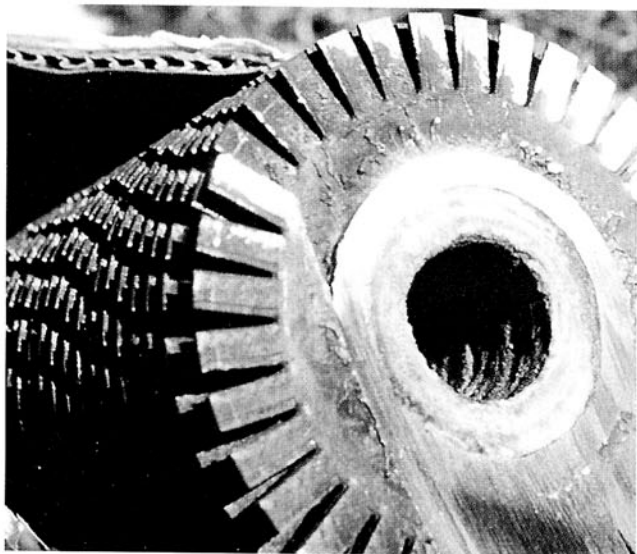
2. Section through high-pressure superheater tube reveals abnormally thick deposits

Actions. Tube samples were cut from each section of the HRSG, including the superheater. Heavy deposits were found throughout the unit, including 0.25-in.-thick deposits in the primary superheater tubes (Fig 2). In order to return the unit to service, two chemical cleanings were required (see details in Case 7b, below). The low-pressure (l-p) turbine rotor was removed from the casing and washed for

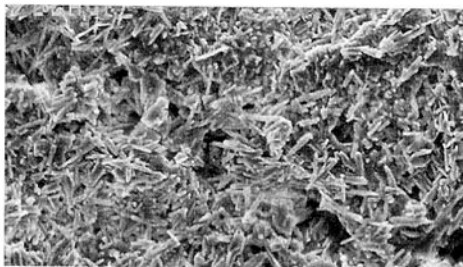
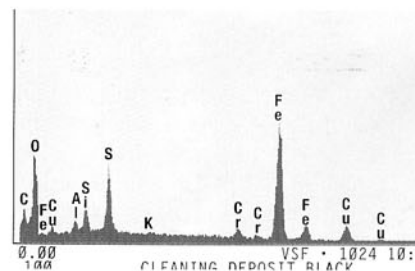
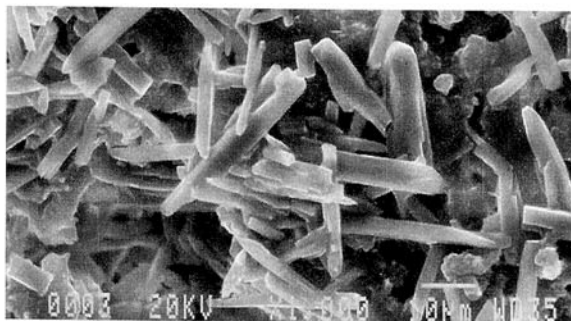
3. Microscopic view of tarry organic deposits from a failed chemical cleaning

Event. The contamination described above (Case 7a) dictated the need for chemical cleaning of the HRSG. Shortly after the start of cleaning, however, the process had to be stopped because of the precipitation of iron citrate and formation of tarry organic deposits (Fig 3).

Root cause. The chemical cleaning of the HRSG after the condenser leak was poorly controlled (pH, temperature, flow) and the high concentrations of chloride and iron oxide in the system quickly overwhelmed the citric acid and inhibitor. This degradation of the cleaning solution chemistry was not immediately detected, resulting in the formation of deposits throughout the cycle—including the condenser—that were difficult to remove.

Actions. Additional inspections and testing were required to develop and apply procedures for a second, corrective chemical cleaning. A special phosphoric acid solution was needed to remove the tarry deposit, before the citric acid cleaning could be repeated. An additional cleaning of the superheater using a hydrofluoric acid solution was also necessary to remove a tightly adherent, chromium-rich deposit.

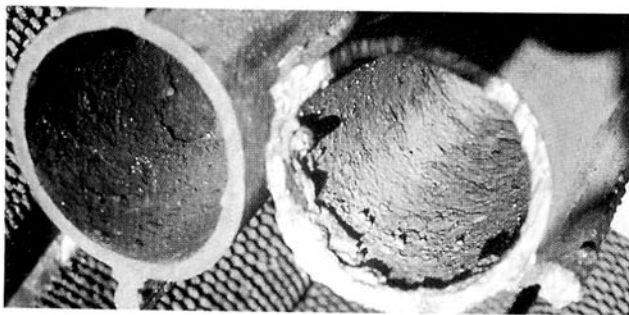
4. Heavy salt and oxide deposit in high-pressure boiler tubes was traced to seawater contamination of condensate

Event. About 30 days into commissioning, HRSG tube leaks occurred. Water chemistry had been outside specified limits for the entire period.

Root cause. When the cover on the barge deck (which doubles as a condensate storage tank) was removed, cycle water was contaminated with seawater splashing aboard. Water chemistry was not properly monitored and there was insufficient training of personnel to recognize the severity of the problem.

Actions. A team of experts evaluated the situation, analyzed water samples, and inspected all equipment. Some HRSG tubes with heavy salt and oxide deposits (Fig 4) were found to have hydrogen damage and there was active corrosion of many components. Several HRSG panels had to be replaced. The whole system was cleaned and the water chemistry problems were corrected.
