PLANT ALERT:

Don't let erosion/corrosion compromise safety

Thinning of pipe walls and corrosion of other components in high-purity feedwater and steam systems can have catastrophic consequences. Take time to review the problem and apply some important preventive steps

By Otakar Jonas, Jonas Inc

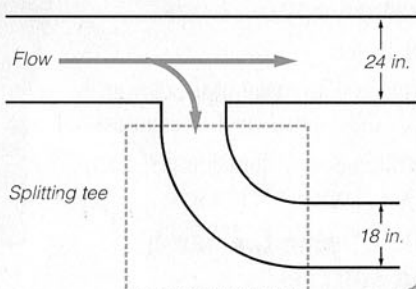
Catastrophic rupture of 18-in.-diam elbow in main boiler-feedpump suction at Surry-2 (December 1986) resulted from erosion-corrosion. Phenomenon reduced 0.50-in. wall thickness to 0.048 in. locally, 0.09 in. in larger areas
