LP Turbine Breakable Diaphragms

Robinson Experience

Rick Dayton – Robinson Nuclear Plant
Otakar (OJ) Jonas, P.E., PhD. – Jonas, Inc

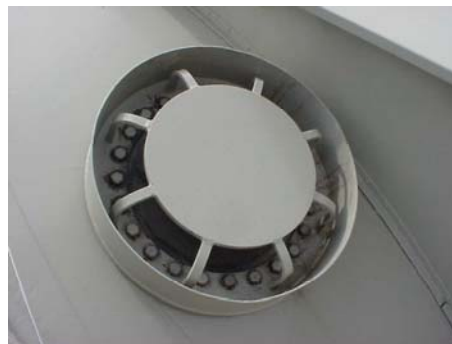
- Purpose – Protects LP turbine and condenser from damage by excessive internal pressure
- Four diaphragm assemblies on each LP turbine outer cover
- Thin diaphragm is broken by underlying steel plate when excessive pressure occurs in the condenser

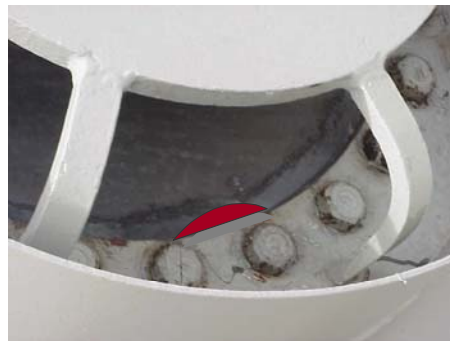
- Leaks can quickly cause condensate oxygen to approach Action Levels and require prompt repair.
- On-line repairs consist of applying thin rubber patches and RTV over the leaking area.

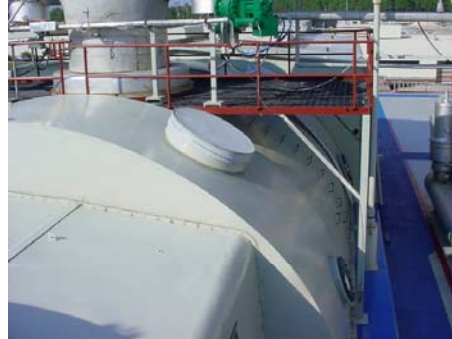
- Robinson approach to leaking diaphragms
 - ◆ Breakable Diaphragm Assembly Covers
 - ◆ Designed and manufactured by Jonas, Inc.

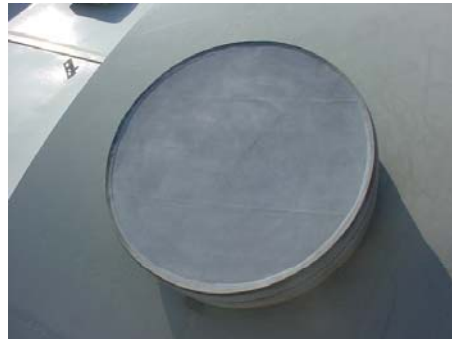
- Jonas covers are presently installed on 4 PWRs, 1 BWR, and 1 combined cycle unit.
- Hypalon outer fabric bonded to neoprene rubber pad.
- Cover is held in-place by a stainless steel band around the assembly collar.
- Collar drain opening must be plugged.

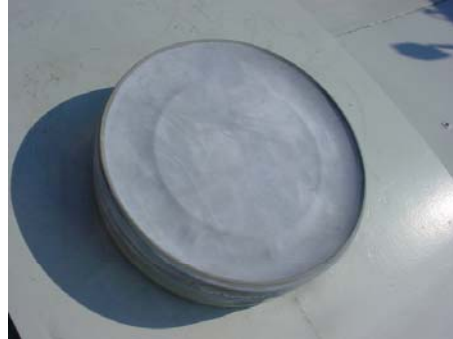
- Cover seals leaking diaphragm thus eliminating air in-leakage.
- Diaphragm repair can be deferred without impacting plant operation.
- Cover also acts as a diaphragm leak indicator.
- Cover design may be stiffened to eliminate need for lead diaphragm.
