Tight control of cycle chemistry key to successful commissioning

By **Dr Otakar Jonas, PE**, and **Lee Machemer, PE**,
Jonas Inc

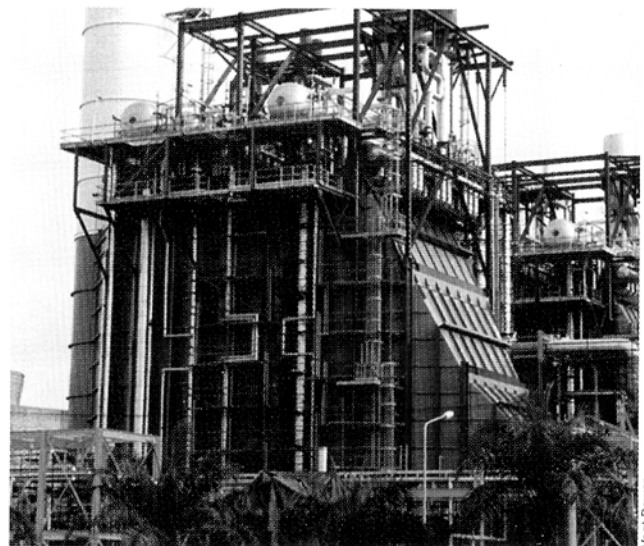
1. Water from hydrostatic test that remains in HRSG panels causes corrosion

Event. A boroscope examination during erection revealed significant amounts of rust in the tubes and headers in many HRSG sections.

Root cause. HRSG sections had not been completely drained after the factory hydrotest and had been inadequately protected during shipment. During erection, black water poured out of the assemblies. The water level during shipment with tubes in the horizontal position was evident in the boroscope videos because the rust was mainly in the bottom half of the tubes (Fig 1).
