# CYCLE CHEMISTRY COMMISSIONING

Otakar Jonas, P.E., Ph.D.  
Lee Macheimer, P.E.  
Jonas, Inc.  
1113 Faun Road  
Wilmington, DE 19803 USA

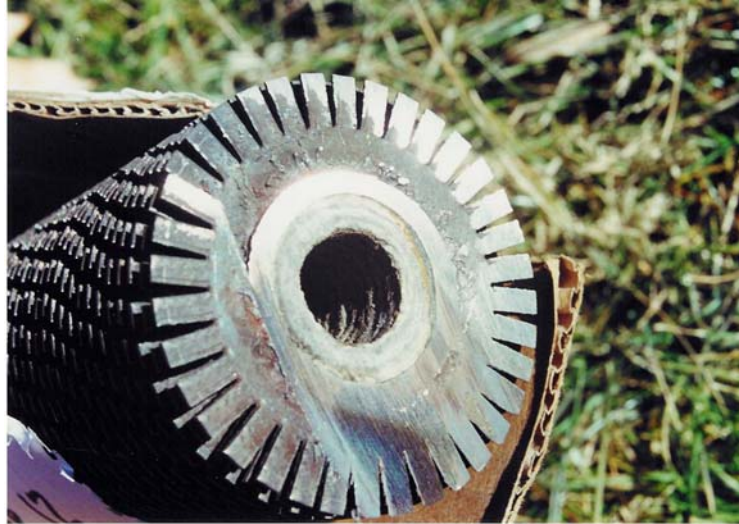
Figure 1  
Heavy Deposit in HP Superheater Tube after Cycle Contamination with Brackish Water

3	Cycle contamination with seawater - several condenser tube leaks during commissioning, including three major leaks (chloride up to 16,000 ppm in boiler water)	Condenser tubes buckled and pulled away from tube sheets, tubes rupture due to improper venting, lack of monitoring, poor communication between chemists and operators	Plug leaking tubes, fill and drain both HRSGs four times, operation on turbine bypass for 7 days to achieve HP steam purity limits
4	During commissioning, unit was shut down due to failure of the HP steam bypass valve to close past 45% due to heavy dark gray deposit (47.7% Cl)	23 condenser tubes had broken, resulting in massive contamination of system, leak not detected due to inoperable and insufficient monitoring, disregard for chemistry	Two chemical cleanings were required (see details in Case 5 below) and commissioning was delayed over 7 months
5	Brackish water contamination (Case 4) results in heavy deposits (0.25 inch (6 mm) thick in primary superheater tubes (Figure 1). Corrective chemical cleaning stopped due to iron citrate and tarry organic deposit formation; Figure 2	Chemical cleaning of the HRSG after a condenser leak was poorly controlled and the high concentrations of chloride and iron in the system overwhelmed the citric acid and inhibitor.	Inspections, testing to determine how to clean system, second corrective chemical cleaning using a special phosphoric acid solution was performed before the citric acid cleaning was restarted

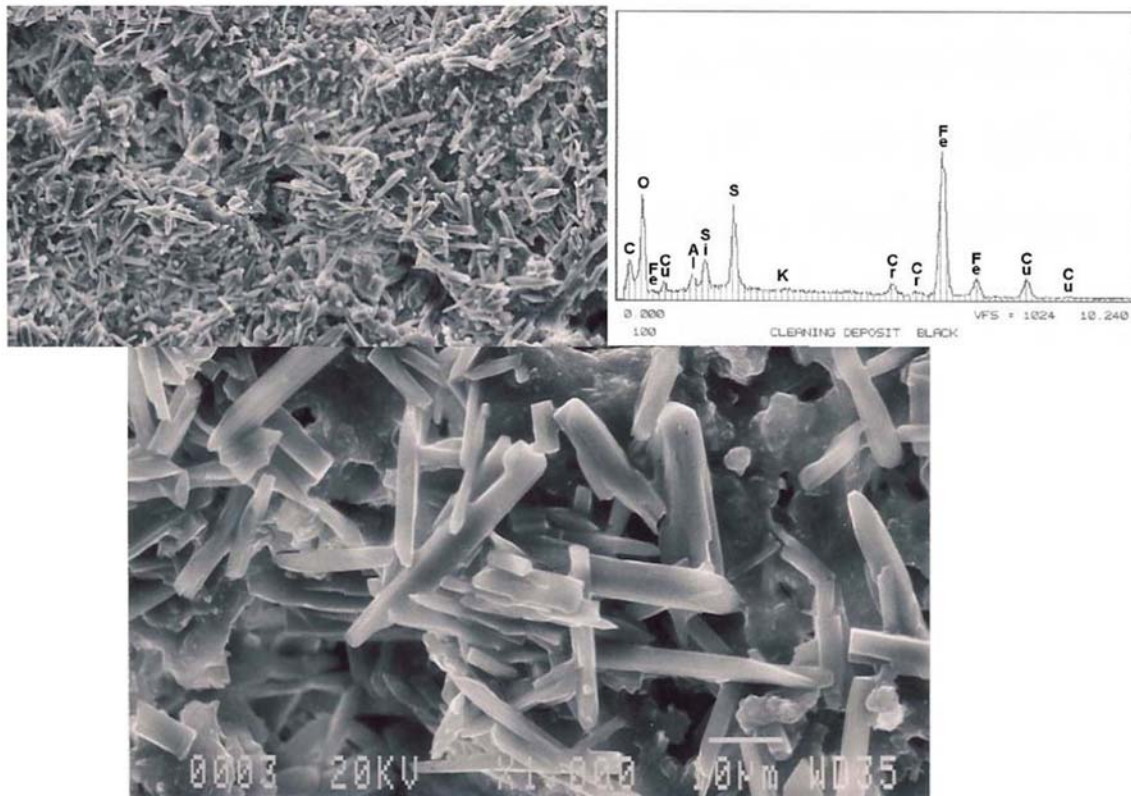
Figure 2  
SEM and Elemental Analysis of the Black Tarry Deposit which Formed after Unsuccessful Chemical Cleaning

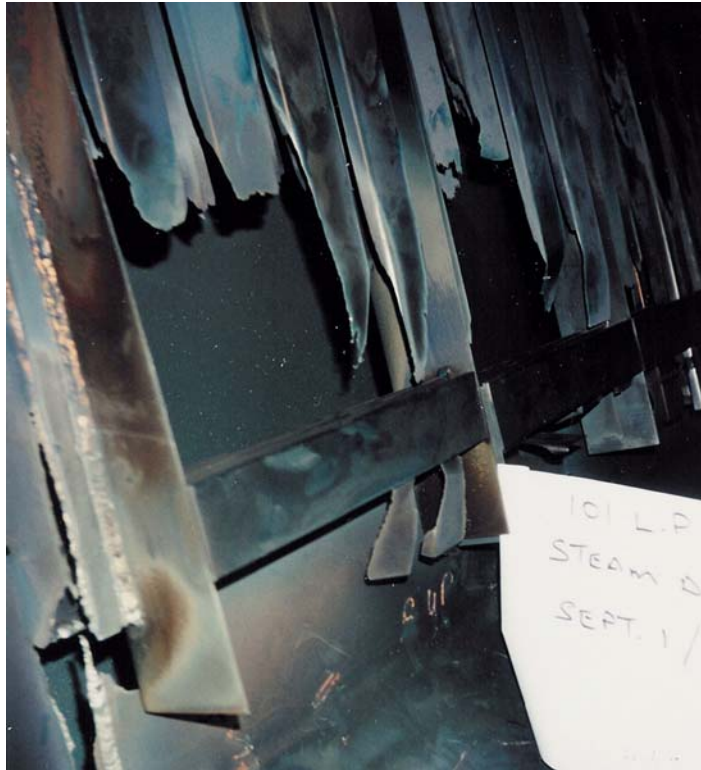
Figure 3  
Flow-Accelerated Corrosion of Carbon Steel Channel Separators in the LP Drum

9	Flow-accelerated corrosion of IP and LP drum internals (Figure 3), Fe in blowdown up to 15 ppm	Water chemistry - decomposition of organics, low pH, high conc. of oxygen scavenger, design - high flow velocity	Replaced with stainless steel, reduced organics and scavenger
<b>Conventional Fossil Boiler Units</b>			
10	Seawater contamination - condenser tube leak increased sodium concentrations and conductivity around the cycle for 12-17 hours	Due to improper installation and loss of cooling water while dumping steam, one condenser tube plug falling out and six loose. The chemistry control was not fully functional and operator and chemist training was inadequate	System drained and refilled 5 times with demin. water. Condenser tube plugs re-installed. Boiler and turbine inspection - OK. Chemical control tightened
11	Pitting and corrosion fatigue of L-1R blades in once-through boiler units	Marginal operation of condensate polishers, blades near resonance	Blade redesign and replacement, improvement of CP operation

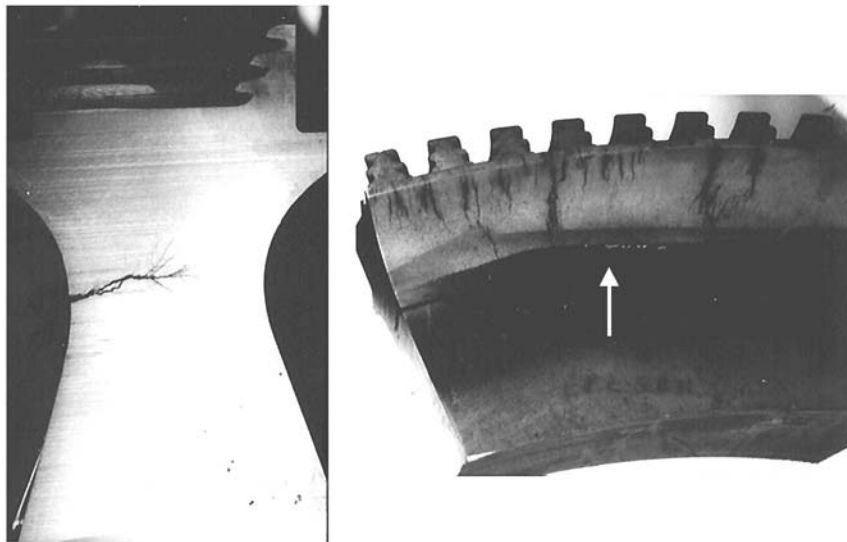
Figure 4  
Massive Stress Corrosion Cracking L-1 LP Turbine Disk caused by High Concentration of NaOH in Steam

12	Stress corrosion of LP turbine disks in a supercritical unit (Figure 4)	Operation of condensate polishers beyond ammonia breakthrough, high NaOH in steam	Disks replaced, operation of CP improved
13	Extensive boiler tube caustic corrosion (Figure 5) in high pressure drum boiler during one year at MCR/overpressure [6]	High heat flux at MCR not compatible with phosphate boiler water control	Replaced tubes, changed to AVT
14	Overheat failures of superheater tubes within one month of operation	High boiler carry-over and heavy deposits in SH because of a missing plug (for a soot blower) in the steam drum	Replaced superheater tubes, installed plug, started steam chemistry monitoring
15	Destructive overspeed of new industrial turbine after 16 hours of operation	High boiler carry-over of boiler water with polymeric dispersant resulted in "gluing" of turbine control valves in the open position	New turbine, carry-over control

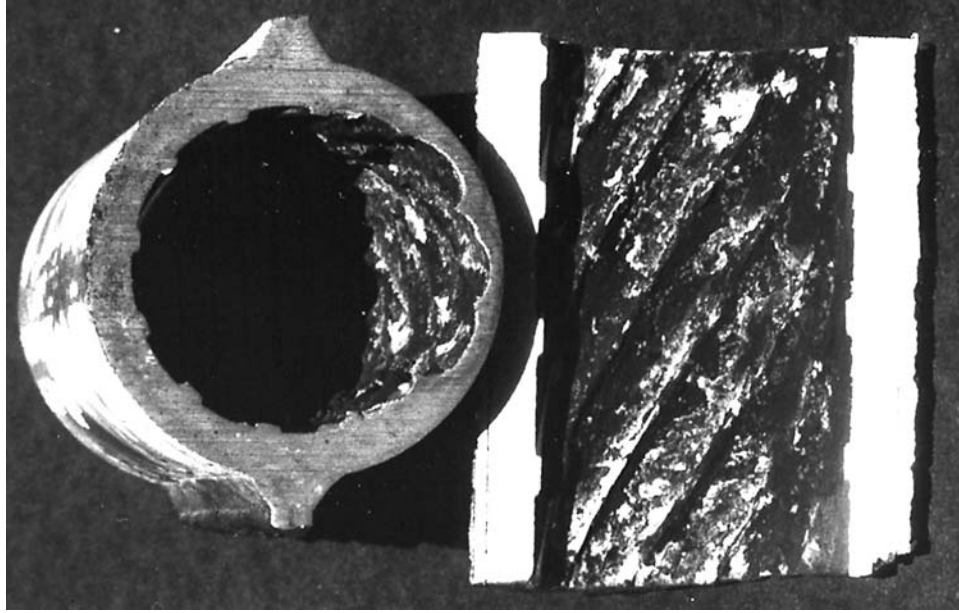
Figure 5  
Corroded Waterwall Tube from a High Pressure Drum Boiler after One Year Operation at MCR

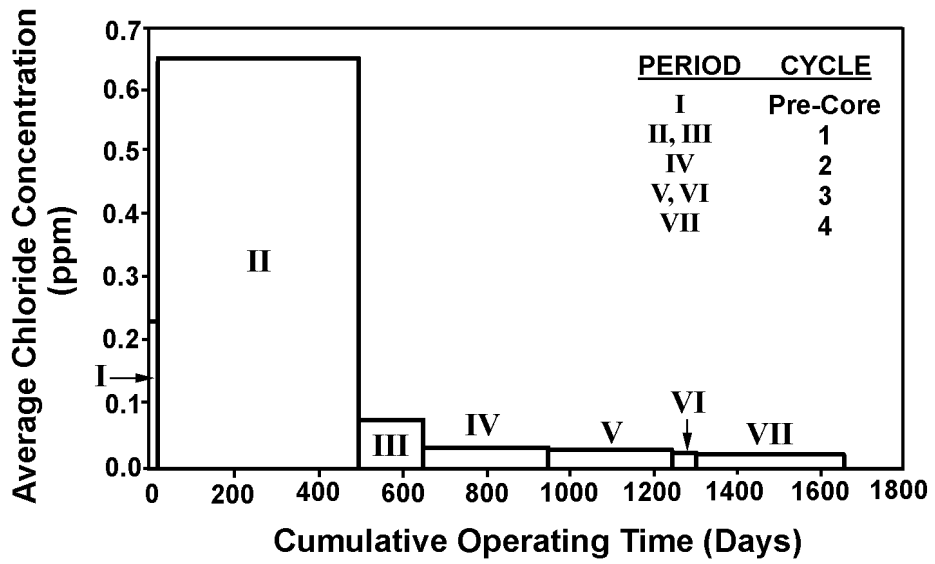
Figure 6  
Chloride Concentration in Steam Generator Water throughout Several Fuel Cycles of a PWR Unit

water chemistry guidelines, and cycle contamination (condenser leaks, air inleakage, malfunctioning condensate polishers) during commissioning and early operation. The results, which have been costly to the nuclear industry include steam generator tube denting requiring steam generator replacement, turbine stress corrosion cracking requiring whole turbine or rotor replacement, and flow-accelerated corrosion of feedwater and wet steam piping and turbine casing. Figure 6 is an example of steam generator water chemistry for a PWR unit using seawater condenser cooling. It illustrates the degree of non-compliance with specified chloride limits during early operation.
